INTREPID INVESTIGATIONS

INVESTIGATION REPORT September 5, 2008

Re: Our Case # 08-327
Subject: Insured Alfredxxxxxxxxk
Type of Investigation: loss/fall, Claimant John xxxxxxxxi
Date Assigned: 09/03/08 Date Investigated: 09/04/08

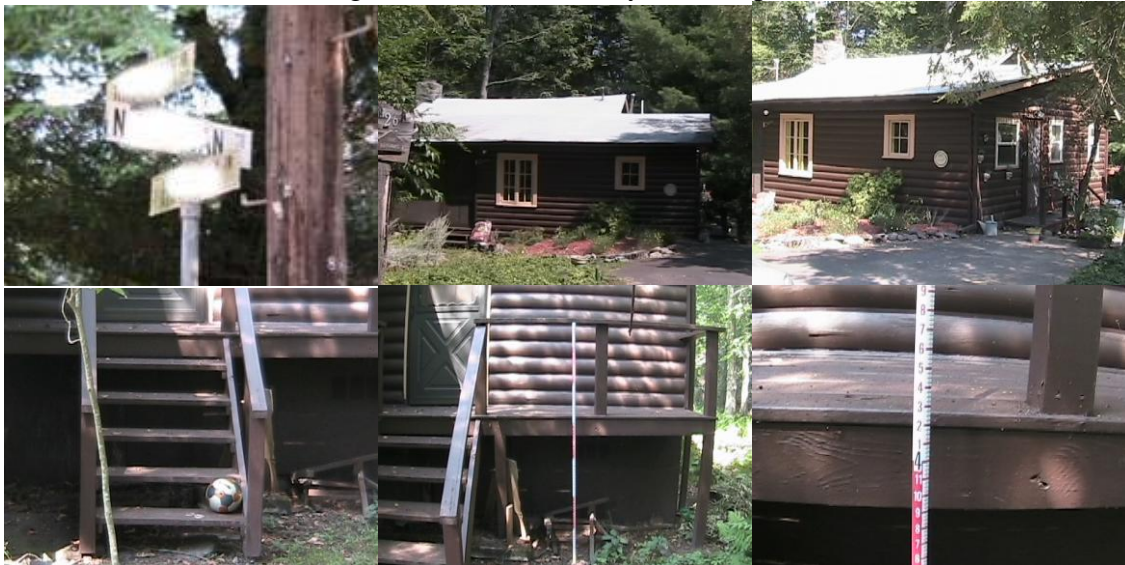
- Appears Subject may have set up the ladder on the ground to the left of the stairs in an area that is only about 24" wide. (photos #19-68)
- The ground is uneven at the location, composed of broken up pieces of rocks, etc.

- At the area to the left, pieces of the gutter are lying on the ground. Either this was an area to be repaired, or the subject knocked them off in a fall.

- Unknown item of plastic on the ground at the possible incident location either construction type plastic cap or medical item, left by possible EMT personnel.

- Insured stated he observed subject lying on the stairs (Insured left a ball at the location to mark the location-photo #41).
- We attempted to contact neighbors but no one was home at either location. We left a business card at the neighbors location-as of yet-no response.

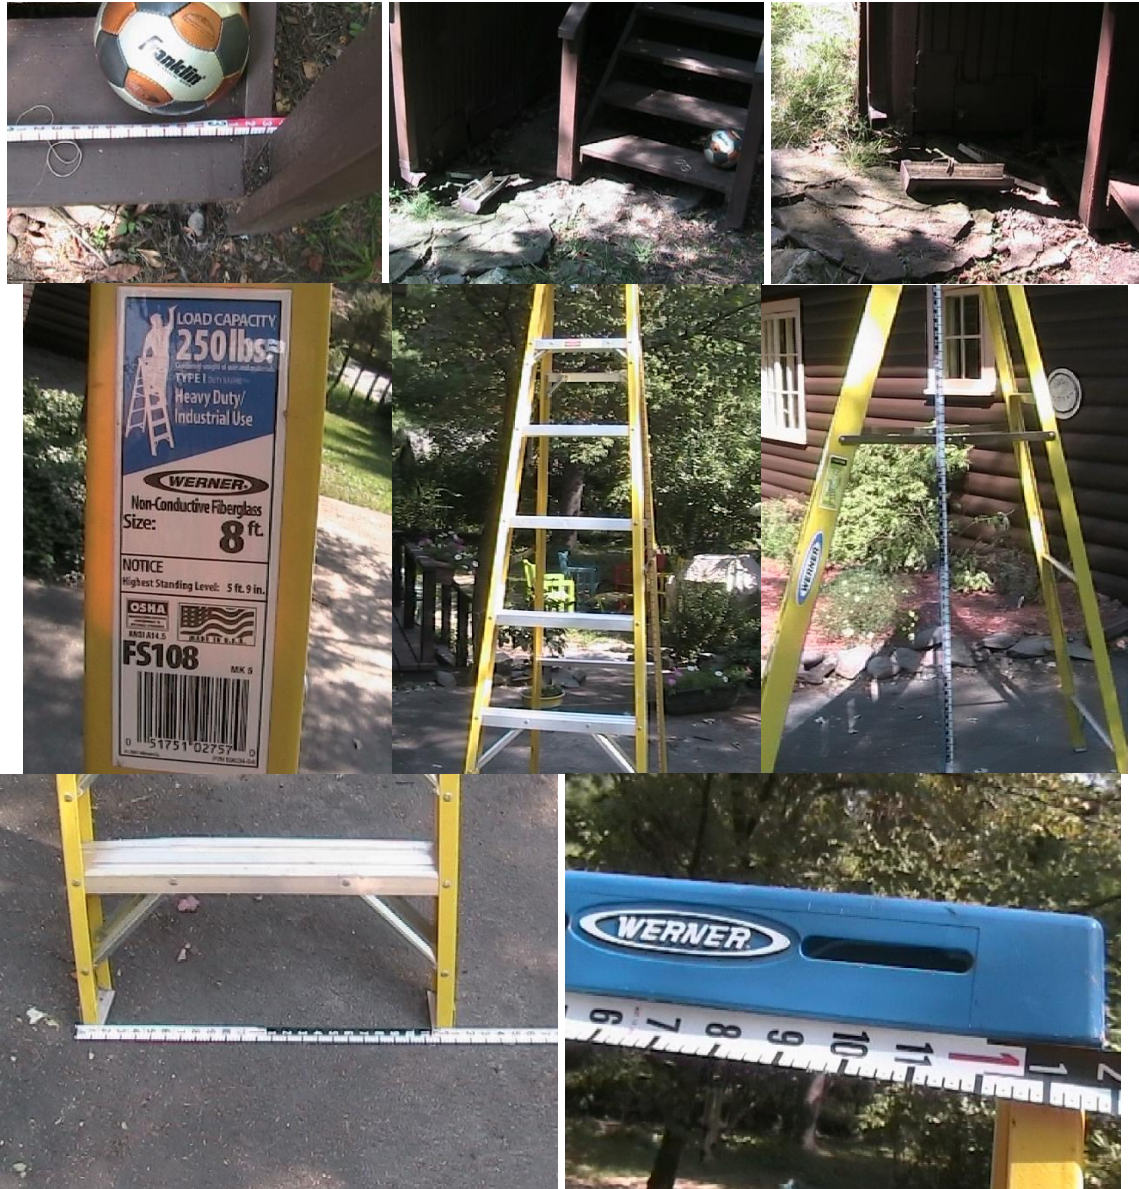
- Subject was using an 8' fiberglass step ladder brand name Werner, ladder was inspected/photographed and does not appear to have any damage and is in new condition. (photos #69-88)

- Ladder information and bar code was obtained (photo #81)
- Ladder is approx 24 inches wide at the base, narrowing to about 12 inches at the top.
- Deck level at the location is about 50 inches from the ground level.
